## ON-ORBIT TEFLON® FEP DEGRADATION

Jacqueline A. Townsend, Patricia A. Hansen  
NASA/GSFC  
Greenbelt, Maryland 20771  
301-286-6685  
jacqueline.a.townsend.1@gsfc.nasa.gov  
patricia.a.hansen.2@gsfc.nasa.gov

### ABSTRACT

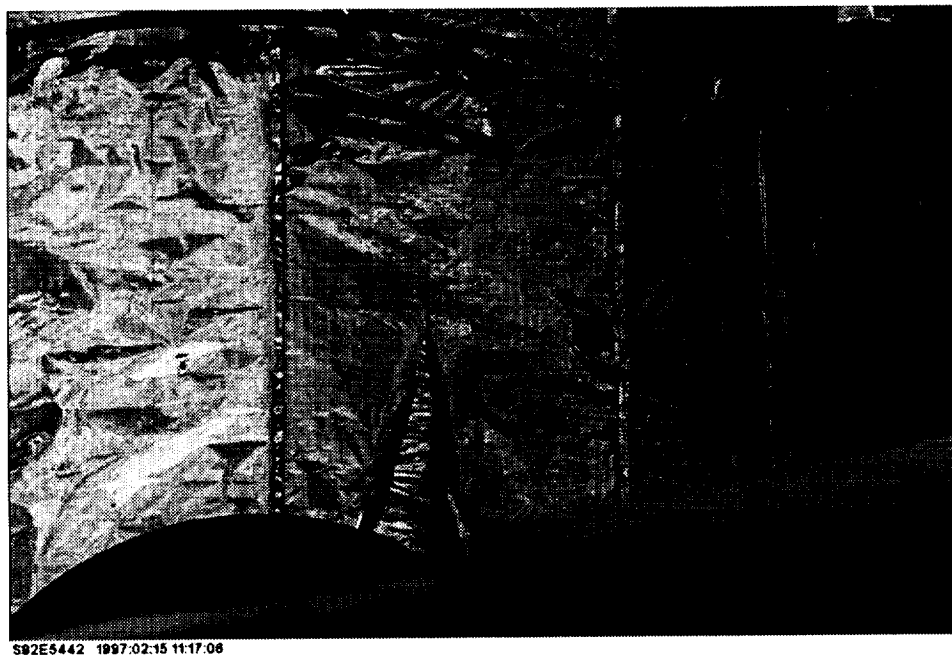
**FIGURE 2: SM2 LS SPECIMEN ON-ORBIT**

During SM2, a specimen from the outer layer of the MLI, shown in Figure 2, was taken from the upper light shield (LS) region of the telescope. The roughly triangular specimen was tightly curled, forming several rolled layers (Figure 2). The astronaut cut the specimen from right to left, with a change in the initial direction as the astronaut realized he was cutting through the roll of the specimen. In Figure 3 the specimen is shown flat with the cracks identified. The specimen was stored in a reclosable polyethylene bag and stowed in a mid-deck locker for the duration of the mission.

The fractures that resulted in the SM2 LS specimen initiated at an edge of the MLI that had been cut to fit around a handrail (Figure 2). From small defects in this cut edge, two fractures developed and propagated in orbit almost normal to one another, resulting in a roughly triangular specimen. The VDA was completely missing from the SM2 LS specimen in regions where the Teflon® FEP was bonded to the rest of the blanket, which included the region where the cracks initiated.

Although the blankets were relatively flat when deployed, photos of the SM2 LS specimen in orbit showed that it was tightly curled, with the space-exposed Teflon® FEP surface as the inner surface and the VDA exposed. This curling indicated a volume shrink gradient in the specimen. Based on the diameter of the curl (1.5 cm) the estimated strain difference between the outer and inner surface of the Teflon® FEP was ~1.5% (3).

The top-center of this image shows the roughly triangular SM2 LS specimen on the Light Shield at SM2 prior to retrieval. A handrail and standoffs are apparent across the top of the image. The specimen is curled very tightly, so that it is detectable here as a triangular region where the next layer of the MLI is visible. The raised feature at the bottom edge of the triangular opening contains the entire specimen that covered this triangle prior to the damage. At the bottom of the image, the tip of the largest crack on HST is seen propagating vertically towards the top of the telescope. This large crack also opened to reveal the next MLI layer.

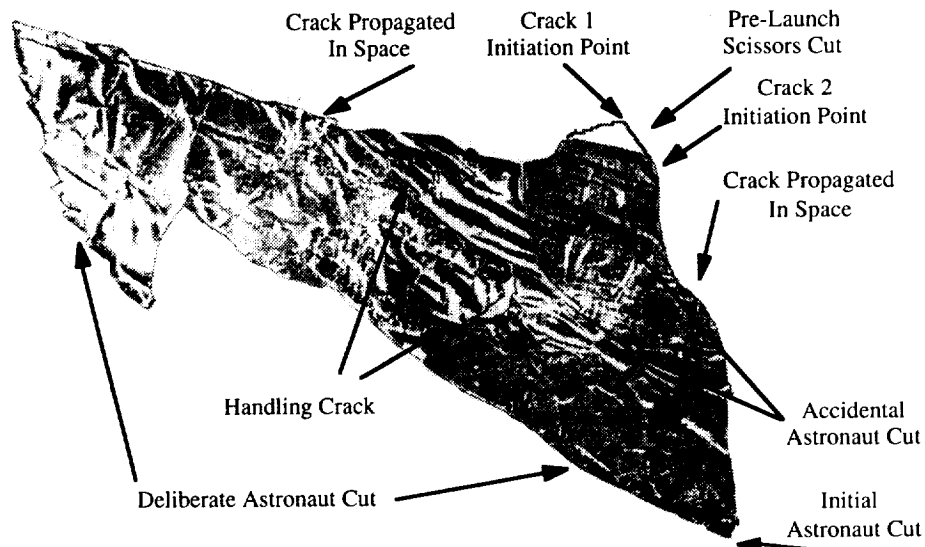
FIGURE 3: SM2 LS SPECIMEN POST-RETRIEVAL

The first task was to document the SM2 LS specimen and assemble the four pieces received into the single specimen that was cut in orbit. Both SEM and optical microscopy were used in this effort. Once the original configuration had been determined, the edges were identified as either a deliberate cut, a handling artifact, or an on-orbit fracture (Figure 3). From this information, the fracture initiation site became apparent.

The image above was taken during post-retrieval analysis, when the SM2 LS specimen was uncurled and placed between glass plates. The edges of the specimen are identified as scissors cut, handling crack, or orbit crack. The top-right corner of the specimen contains the crack initiation sites.
